Safety Inspection Report

Annual Inspection

Castle Park, off Joe Blunts Lane

12 September 2019

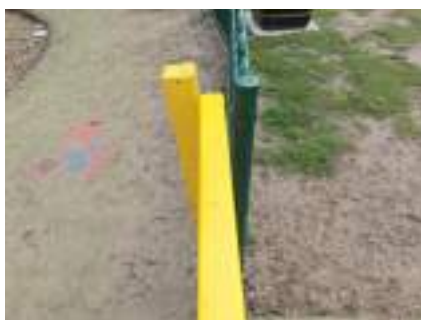
The supports are loose in the ground.

Slam post loose in the ground.

Re-set.

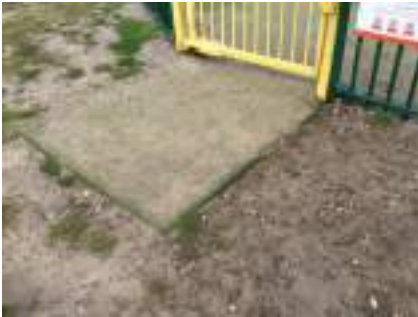
Trip points on the surface.

Make level., Remove trip points.

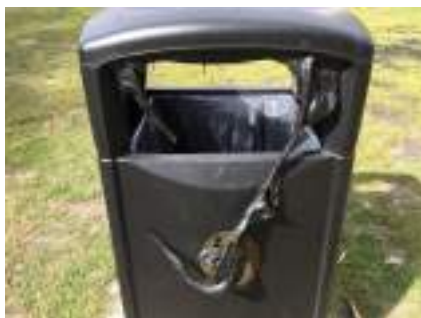
Vandalised (arson).

Black bin near climbing multiplay.

Repair.

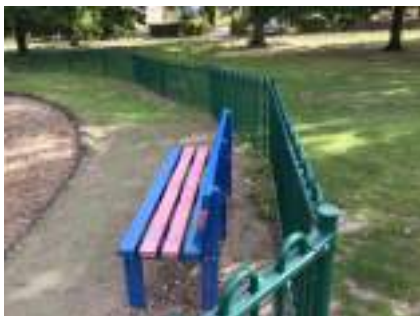
RoSPA recommend a minimum distance of 1 m between seat and fence. This is to reduce the likelihood of children vaulting the fence via the seat.

No reasonably practicable action is identified.

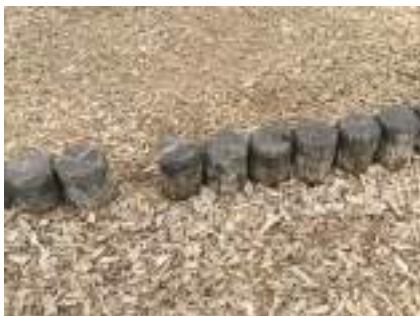
Timber is decayed.

Some bark border posts are decayed and missing.
Decking bridge slats are decayed.

Check on a routine basis., Replace affected parts.

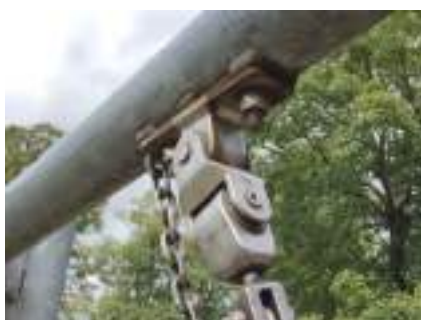
Fixtures loose or missing.

Shackles slightly loose.

Tighten/replace.

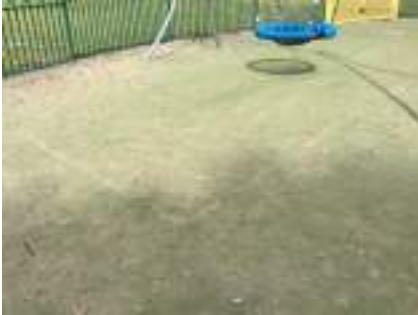
Debris on surface.

Sweep away debris on a routine basis.

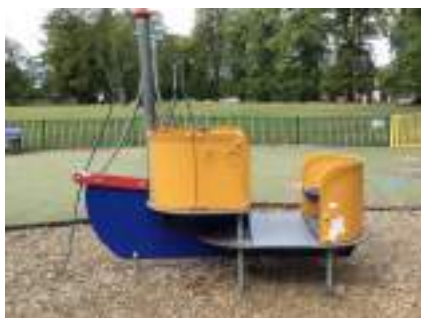
Fixtures loose or missing.

Various fixings are starting to loosen.

Tighten/replace.

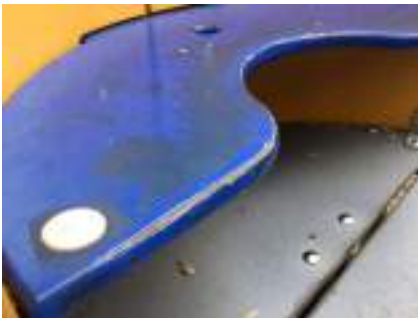
Laminate damaged.

Seat.

Rub down and treat damaged edges.

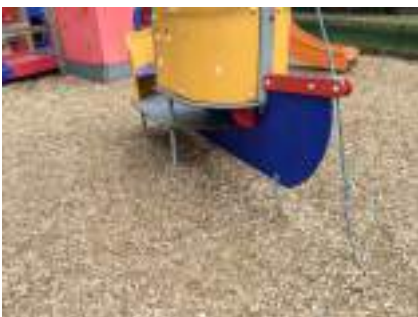
Surface is compacted or displaced.

Rake and fork over and top up as required to maintain minimum depth (usually 300 mm).

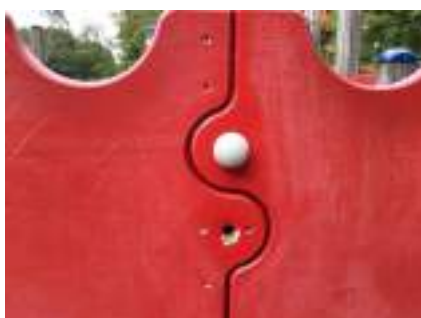
Bolt(s) missing.

Board next to yellow talking speaker. Screws have been used to secure panel down.

No reasonably practicable action is identified.

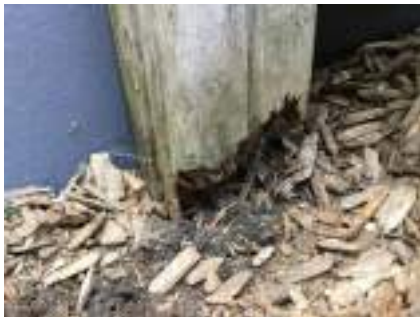
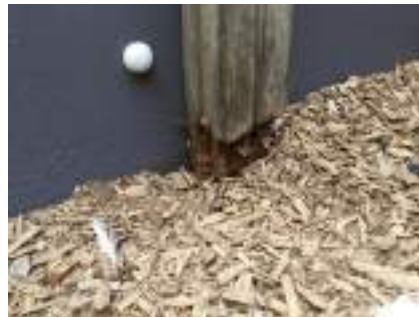
Item is at the end of its useful working life.

Almost all posts are decaying or softening - recommend replacement.

Check on a routine basis., Replace affected parts., We recommend resistograph testing to determine the internal condition of the timber,. We can undertake this testing at additional cost. Please contact us for details., Programme early replacement.

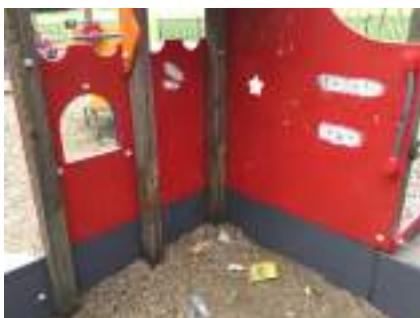
Item has some parts missing.

Seats.

Replace the missing parts.

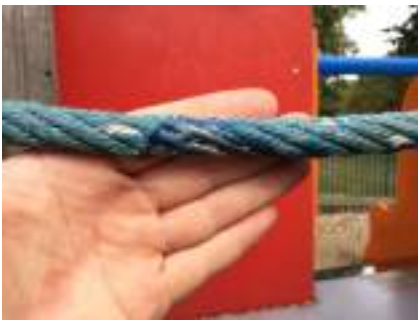
Vandalised (arson).

Rope to large slide.
Rope rail, little slide platform.
Wire core exposed.

Repair.

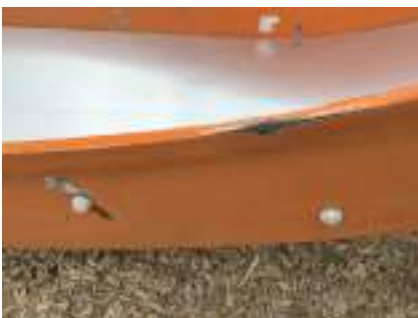
Laminate damaged.

Slides.

Rub down and treat damaged edges.

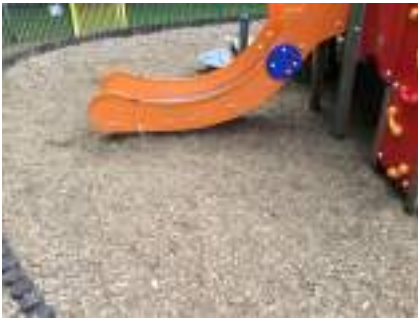
Surface is compacted or displaced.

Rake and fork over and top up as required to maintain minimum depth (usually 300 mm).

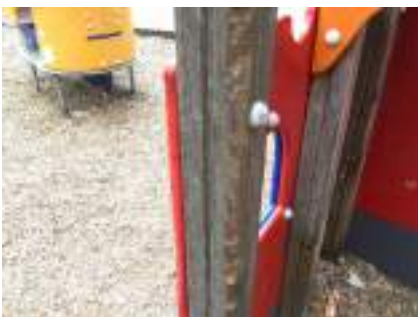
Timber is smashed.

Archway posts.

Repair.

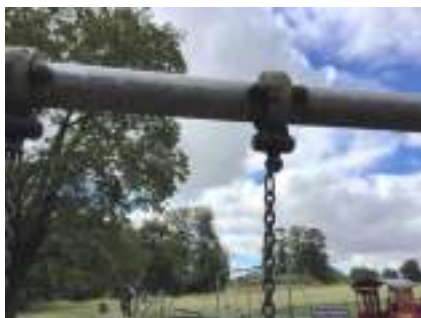
The covers should be removed from the fitting at the top of the chain annually and the shackle bolt should be checked for wear.

Replace at 70% of original diameter (30% wear).

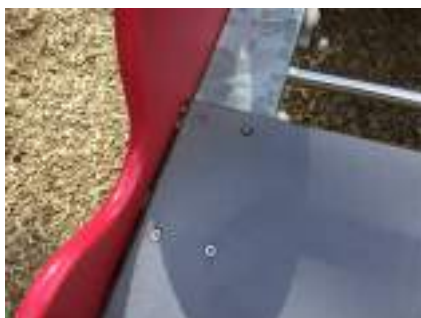
Rivets are missing.

Seat.

Replace.

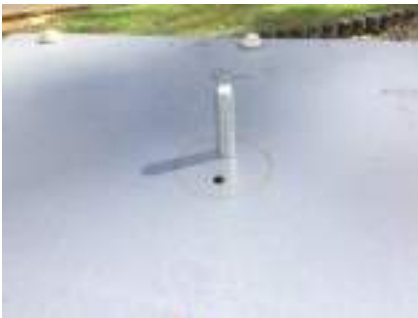
Item has some parts missing.

Top of unit is missing a part. Potential finger entrapment present.

Replace the missing parts.

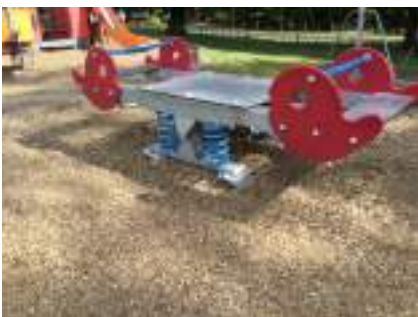
Surface is compacted or displaced.

Rake and fork over and top up as required to maintain minimum depth (usually 300 mm).

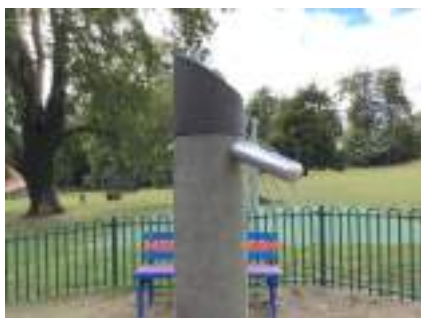
Bolt is missing.

Bolt missing on chimney, leaving a potential finger trap.

Replace.

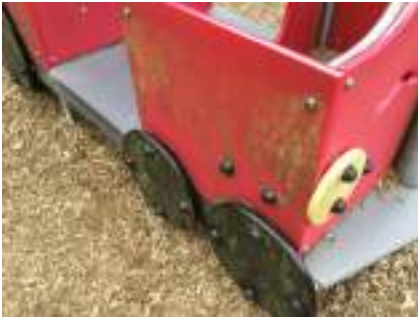
The equipment is dirty or algae covered.

Clean off.

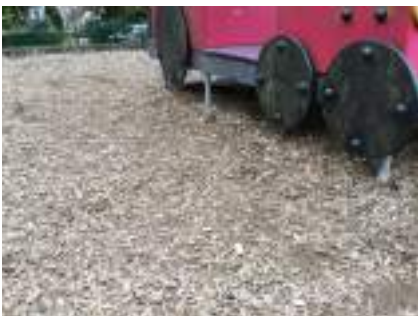
Surface is compacted or displaced.

Rake and fork over and top up as required to maintain minimum depth (usually 300 mm).

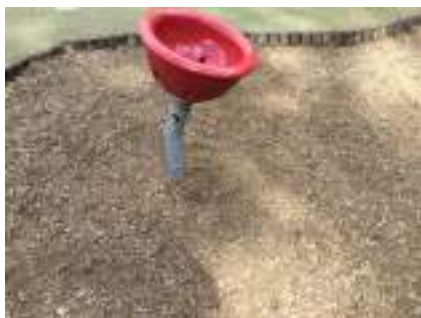
Loose fill levels are too low to provide adequate protection.

Top up to required depth (usually 300 mm).

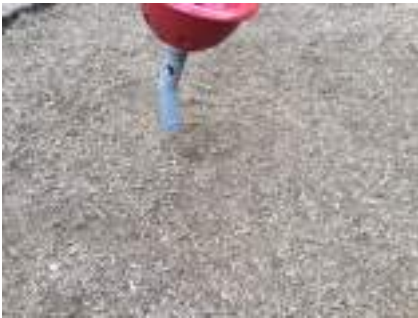
Surface is compacted or displaced.

Rake and fork over and top up as required to maintain minimum depth (usually 300 mm).

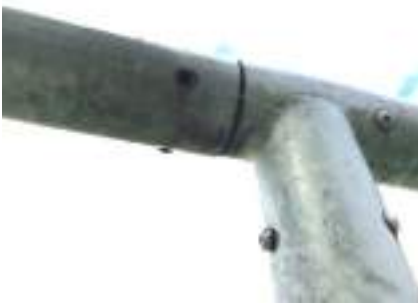
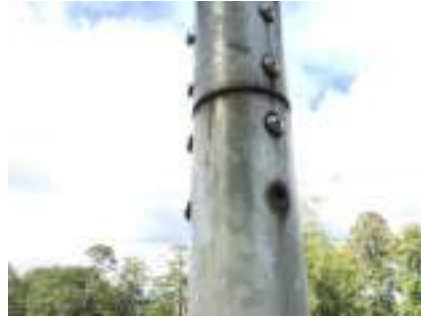
Bolt(s) missing.

Central post and cross beam.

Tighten/replace.

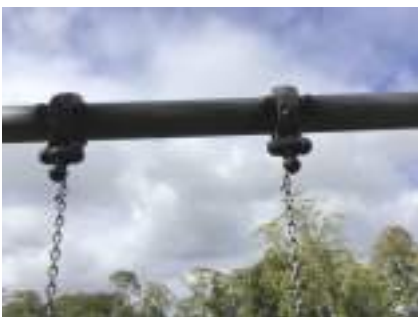
The covers should be removed from the fitting at the top of the chain annually and the shackle bolt should be checked for wear.

Replace at 70% of original diameter (30% wear).

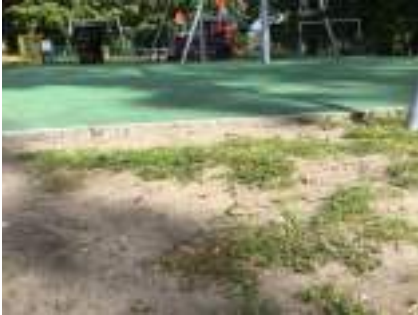
Trip points on the surface.

Make level., Remove trip points.

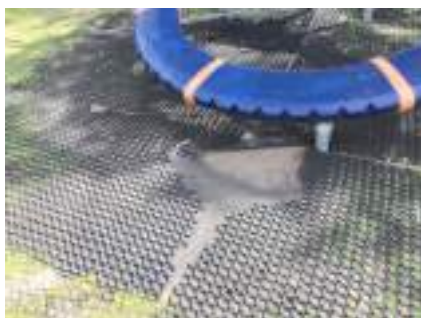
Surface needs repair.

Mats damaged and missing - repair / replace.

Repair., Replace.

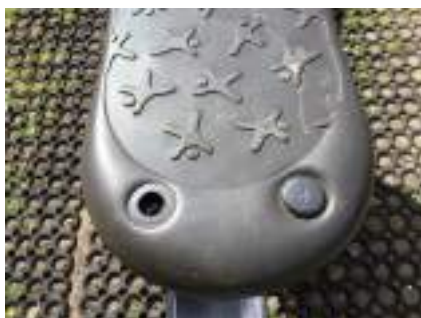
Bolt(s) missing.

Bolt x 1 from traveller.

Replace missing bolt(s).

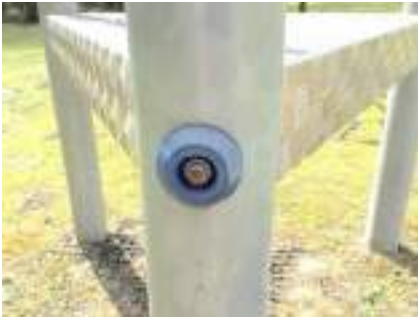
Cap missing.

Replace.

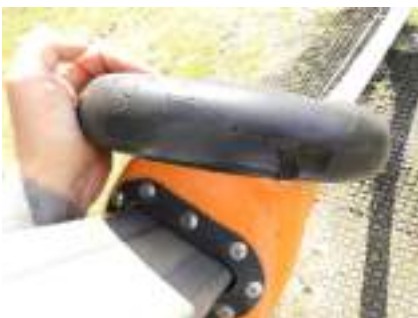
Item is damaged.

Rubber traveller damaged - monitor.

Read the notes for further action.

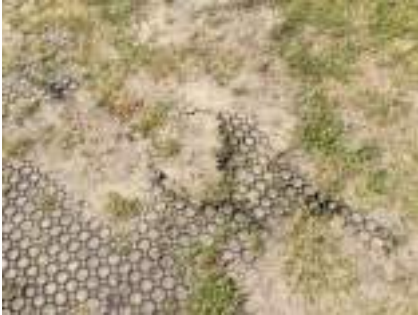
Surface needs repair.

Repair.

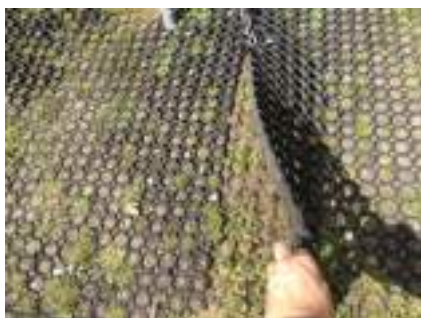
Surface needs repair.

Grass matting is splitting.

Repair.
