Safety Inspection Report

Annual Inspection

Pine Close, IP24 3LA

Thetford Town Council

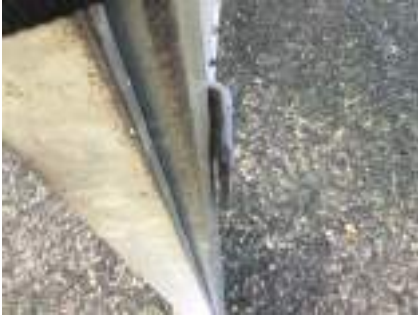
Gate buffer(s) required.

Fit a buffer.

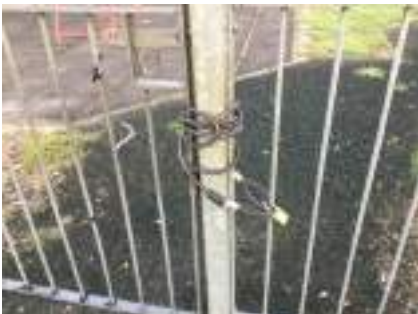
Mechanism needs adjustment.

Gate locked at time of inspection, ensure mechanism is working correctly when unlocked.

Adjust.

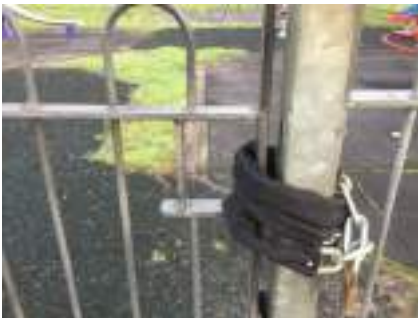
Item has some parts missing.

Bar on gate missing, allowing animals to enter.
Bolt is also missing.

Replace the missing parts.

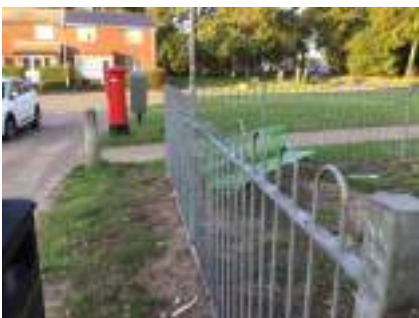
Item is damaged.

Bent.

Repair.

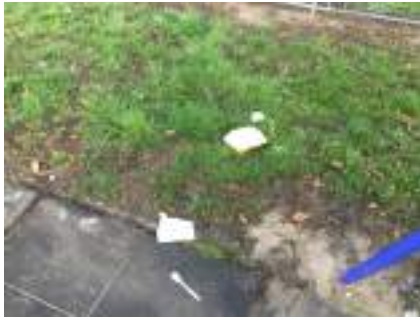
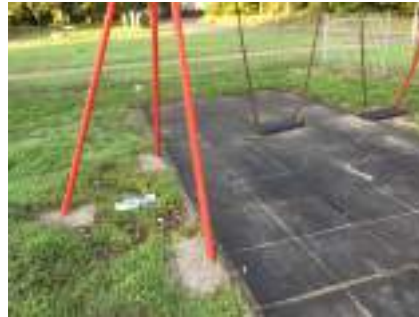
Litter on site.

Clean up.

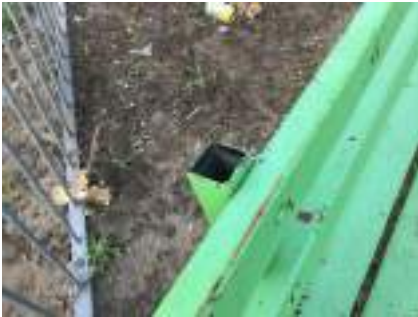
Cap missing.

Replace.

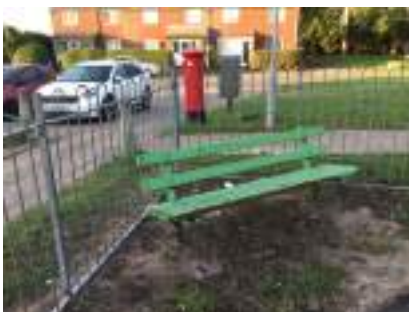
RoSPA recommend a minimum distance of 1 m between seat and fence. This is to reduce the likelihood of children vaulting the fence via the seat.

No reasonably practicable action is identified.

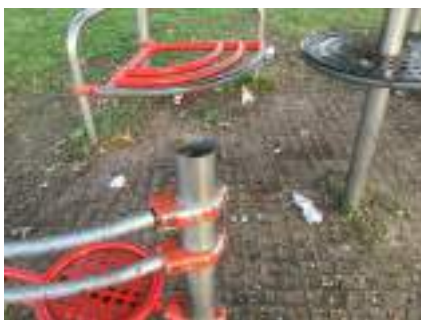
Cap missing.

Replace.

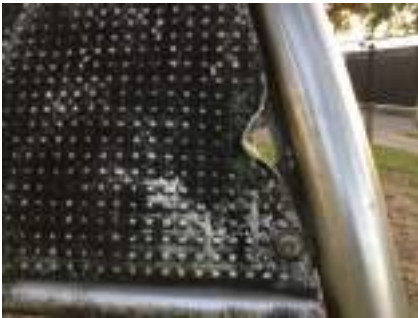
Item is damaged.

Roof panel.

Repair.

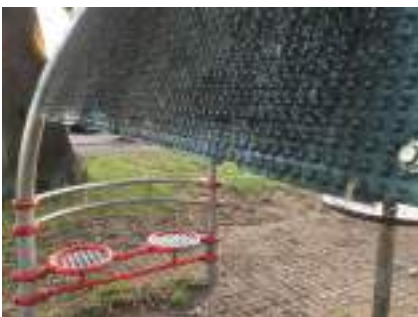
Item has some parts missing.

Metal coping for roof panel missing, leaving sharp areas exposed.

Replace the missing parts.

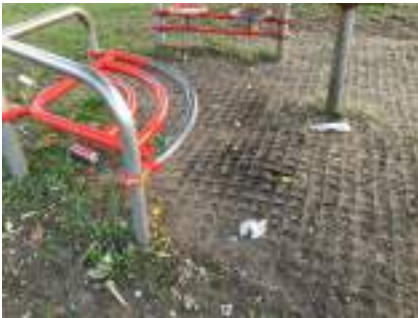
Site litter - Requires clearing up.

Read the notes for further action.

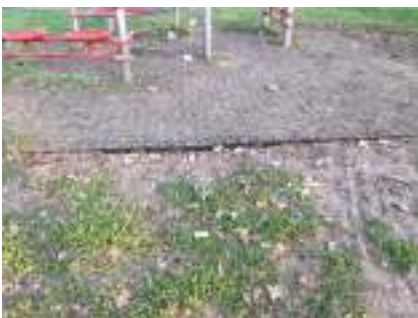
Trip points on the surface.

Make level., Remove trip points.

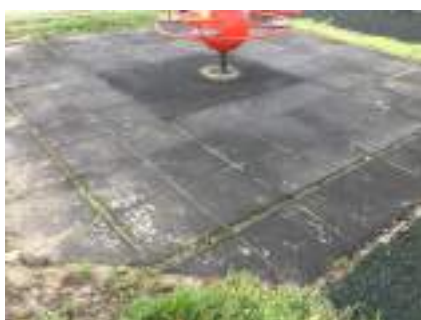
Gaps have opened up between tiles causing trip hazard.

Grass and weeds present - Remove.

Re-glue and fill gaps and joints as necessary., Refit the tiles.

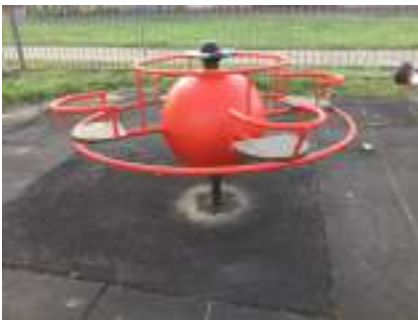
Minor repairs are needed.

Unit has some wobbling to the main ball - Refer to manufacturer for guidance on maintenance.

Repair.

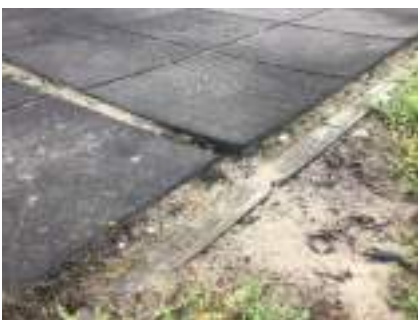
Trip points on the surface.

Edges of tiles and tiles themselves are lifting - Repair.

Repair.

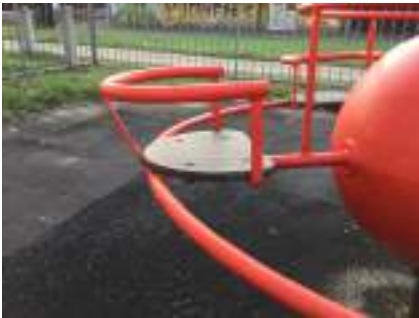
There is a head entrapment.

The unit was installed prior to the publication of the current standards. There is no requirement to make retrospective changes.

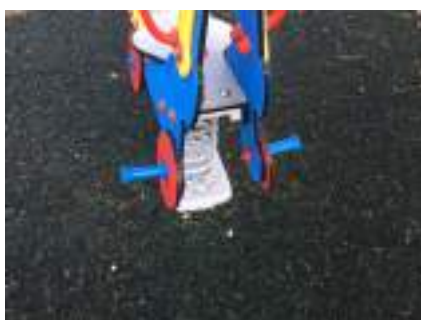
Fixtures loose or missing.

Foot rests.

Tighten/replace.

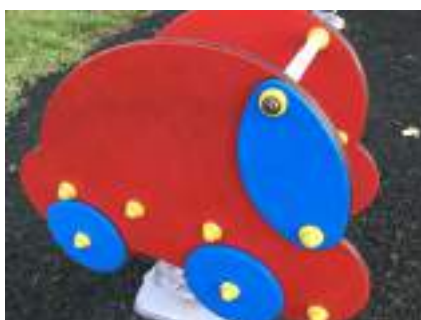
Cap missing.

Handle bar caps.

Replace.

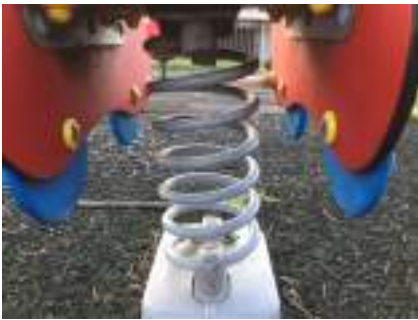
Bolt(s) loose.

Frame bolts loose to spring. Tighten.

Tighten.

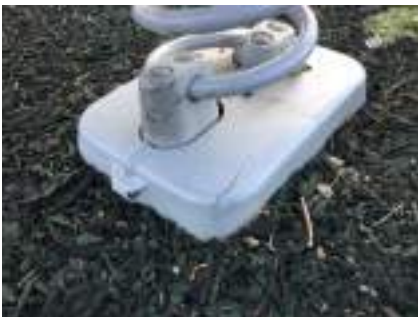
Item is cracked.

Base cover.

Repair.

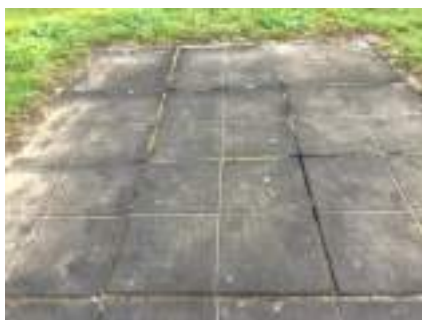
Gaps have opened up between tiles causing trip hazard.

Grass and weeds present - Remove.

Refit the tiles., Re-glue and fill gaps and joints as necessary.

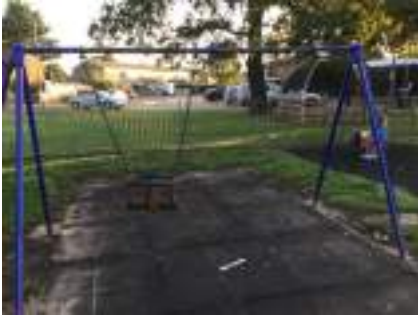
Swing seat(s) missing.

Replace.

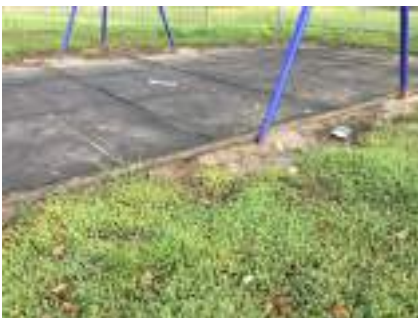
Trip points on the surface.

Make level.

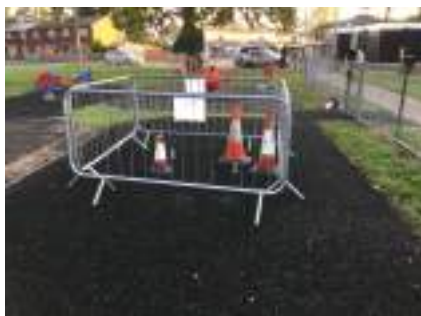
Item has been immobilised, fenced or removed to prevent use.

Reinstate properly.

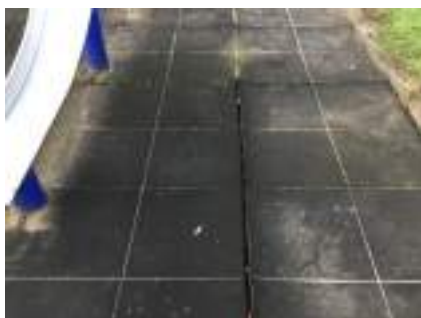
Gaps have opened up between tiles causing trip hazard.

Grass and weeds present - Remove.

Re-glue and fill gaps and joints as necessary., Refit the tiles.

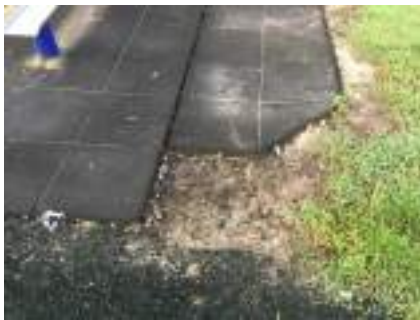
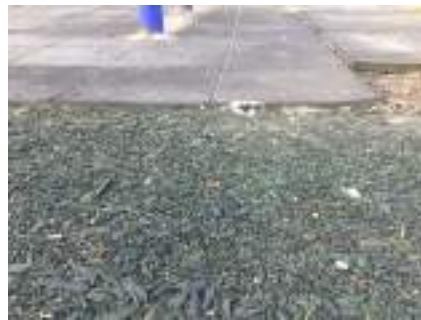
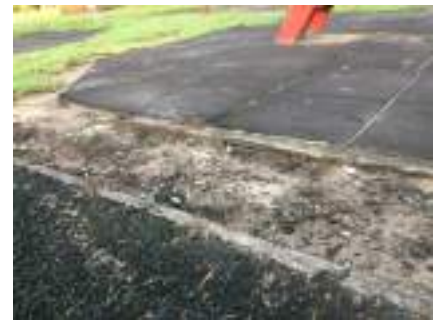
Trip points on the surface.

Along the wooden edges and connection joint to rubber mulch. some matts and edging are missing - Replace.

Make level., Repair.

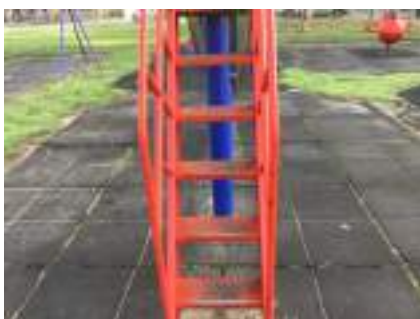
Access fails the entrapment requirements.

The unit was installed prior to the publication of the current standards. There is no requirement to make retrospective changes.

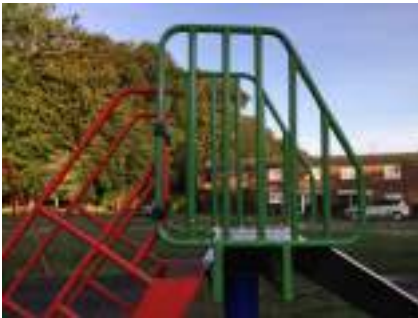
The spacing between the barrier bars is in excess of 89 mm.

The unit was installed prior to the publication of the current standards. There is no requirement to make retrospective changes.

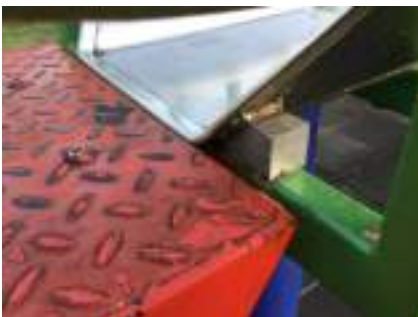
There is a toggle entrapment.

Eliminate the entrapment., The unit was installed prior to the publication of the current standards. There is no requirement to make retrospective changes.

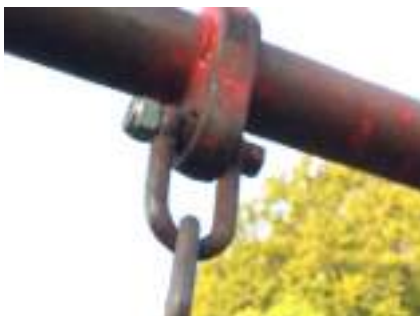
There is wear in the bushes.

Remove shackle bolt and check bush and shackle pin wear, replacing as necessary.

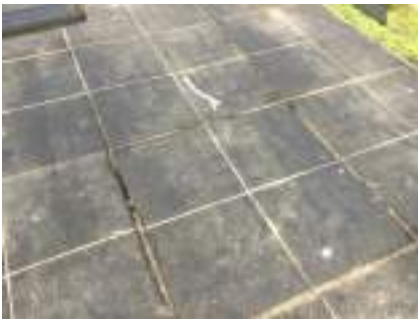
Gaps have opened up between tiles causing trip hazard.

Grass and weeds present - Remove.

Re-glue and fill gaps and joints as necessary., Refit the tiles.

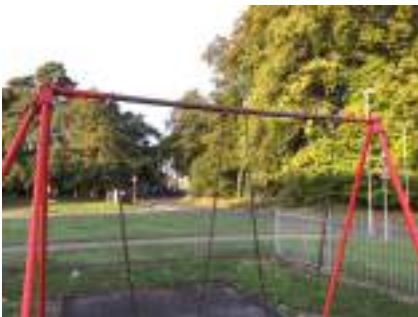
Bolt(s) loose.

Cross bar is loosening in support housing. Tighten.

Tighten.

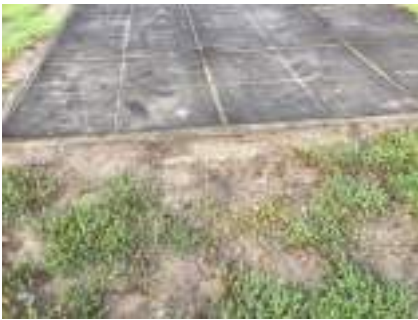
Trip points on the surface.

Raise soil levels.

Make level.

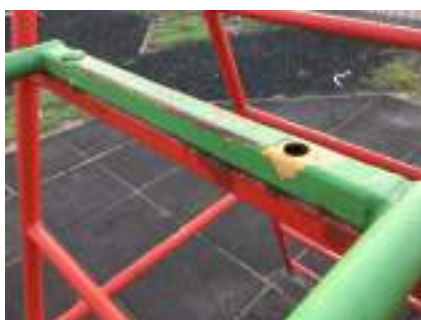
Fixtures loose or missing.

Ladder, creating a potential finger entrapment.

Tighten/replace.

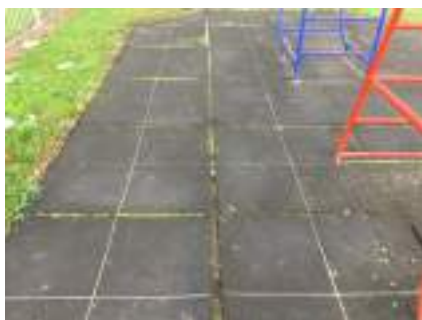
Gaps have opened up between tiles causing trip hazard.

Grass and weeds present - Remove.

Re-glue and fill gaps and joints as necessary., Refit the tiles.

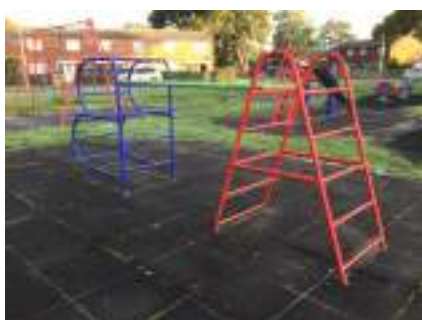
RoSPA is concerned by accidents on some types of overhead ladders and rings. However, there is a strong development value in these items.

The protective surface under all bars and rings must be kept in good condition.

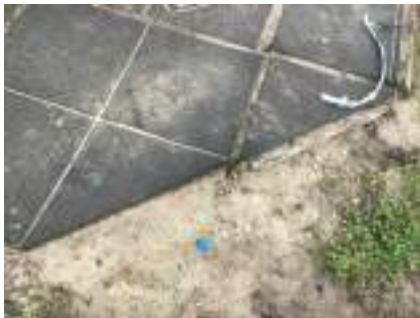
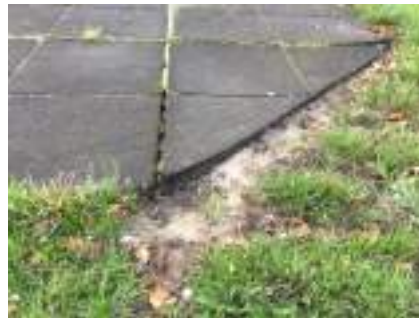
Minor repairs are needed.

Tiles lifting and wooden edging is missing / decayed.

Repair., Replace.

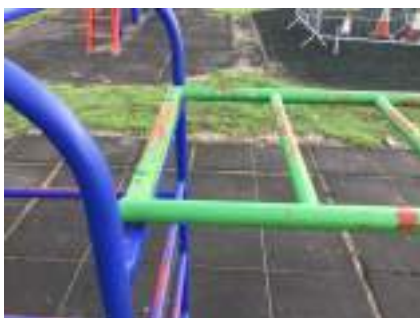
There is a head entrapment.

Ladder does not have 230 mm clearance between rungs - No action required.

The unit was installed prior to the publication of the current standards. There is no requirement to make retrospective changes.
