Safety Inspection Report

Annual Inspection

Castle Park, off Joe Blunts Lane

12 September 2019

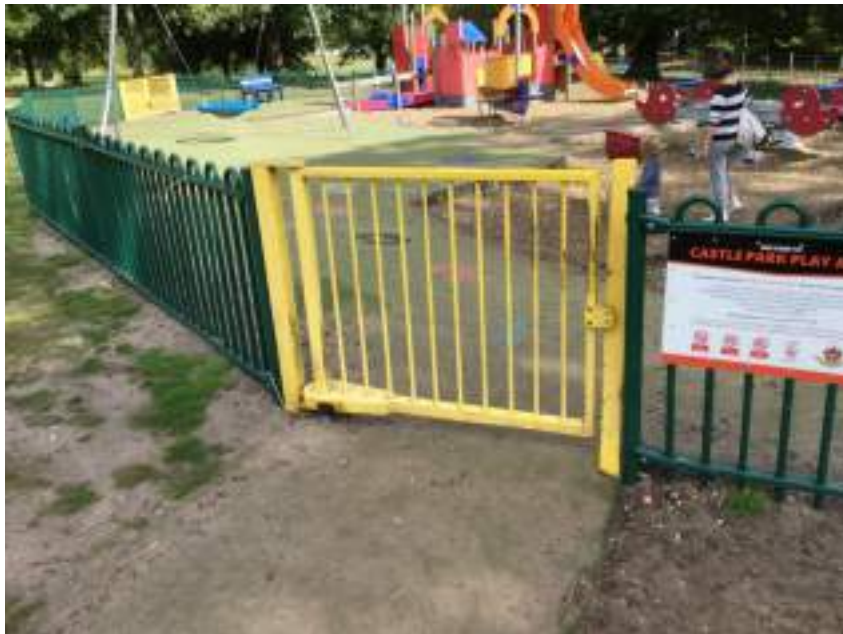
Gates

The supports are loose in the ground.

Slam post loose in the ground.

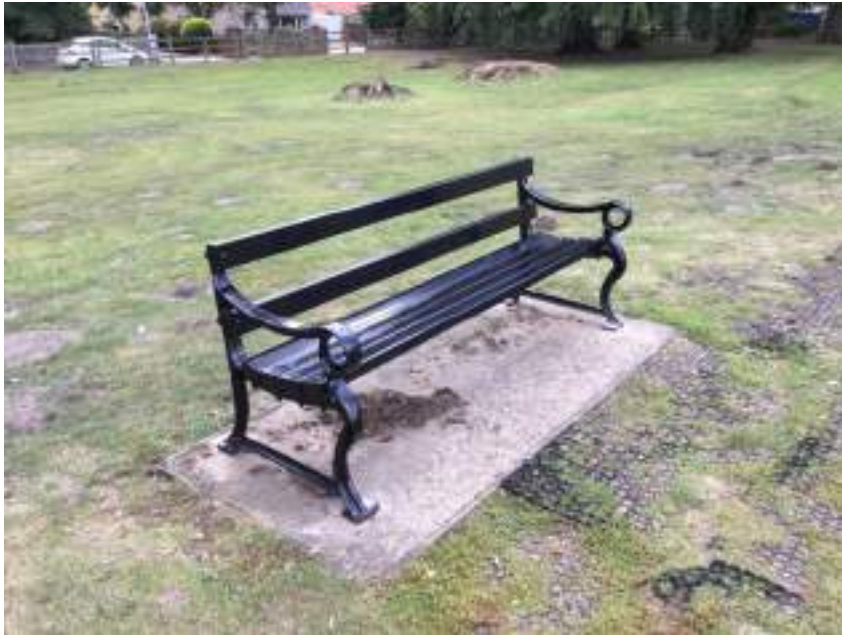
Seating

RoSPA recommend a minimum distance of 1 m between seat and fence. This is to reduce the likelihood of children vaulting the fence via the seat.

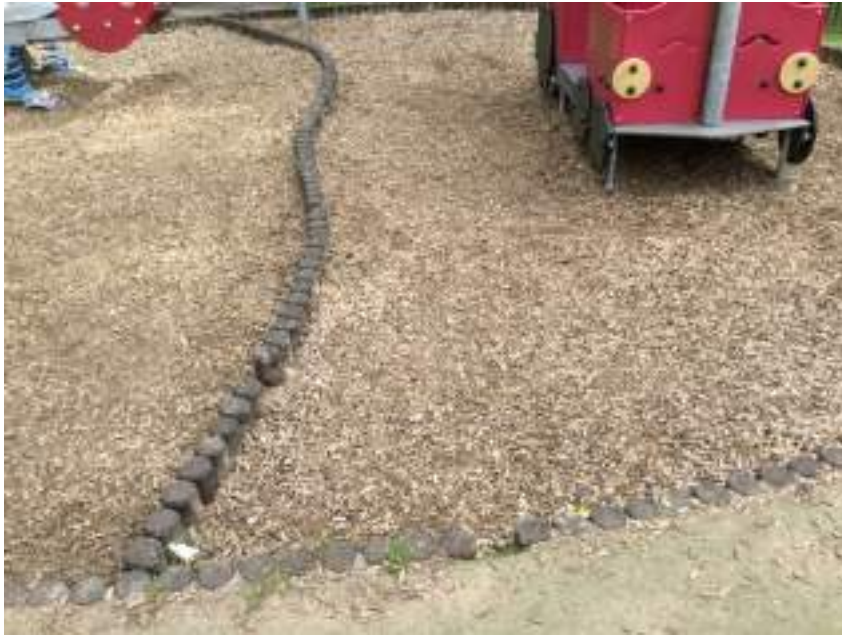
General Surface - Bark Chip

Timber is decayed.

Some bark border posts are decayed and missing.
Decking bridge slats are decayed.

Check on a routine basis., Replace affected parts.

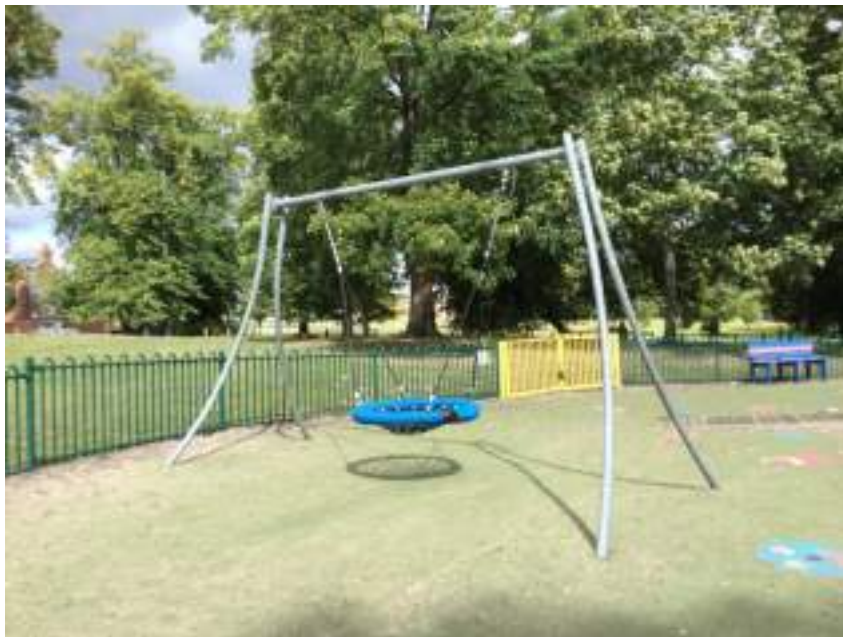
Swing - Basket

Fixtures loose or missing.

Shackles slightly loose.

Tighten/replace.

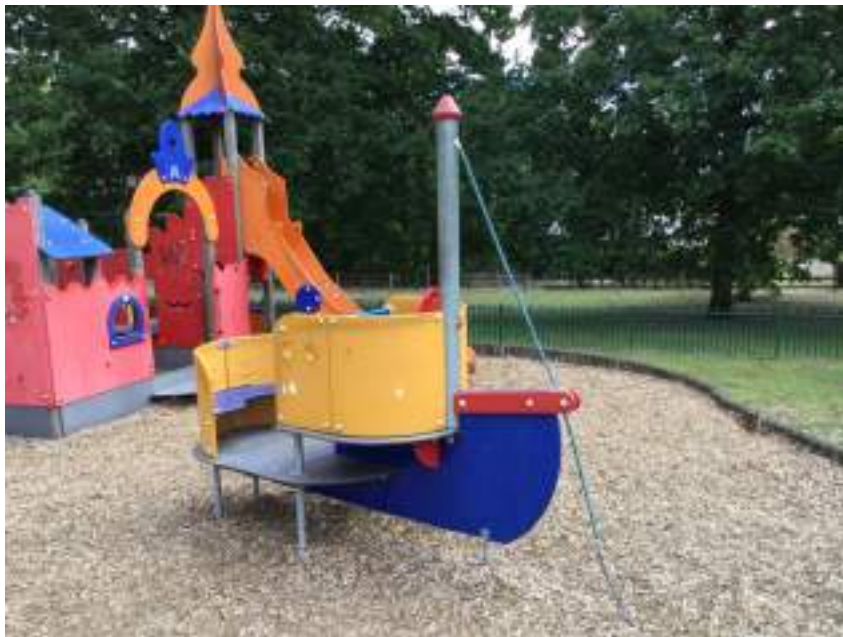
Play Boat

Fixtures loose or missing.

Various fixings are starting to loosen.

Laminate damaged.

Tighten/replace.

Rub down and treat damaged edges.

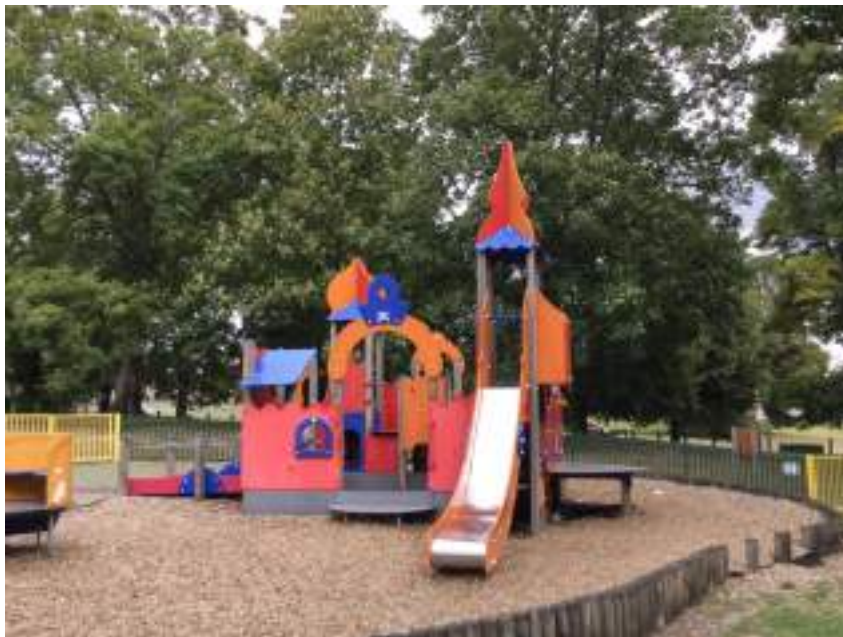
Multiplay - Toddler - Castle

Bolt(s) missing.

Almost all posts are decaying or softening - recommend replacement.

Item has some parts missing.

Laminate damaged.

Check on a routine basis., Replace affected parts., We recommend resistograph testing to determine the internal condition of the timber,. We can undertake this testing at additional cost. Please contact us for details., Programme early replacement.

Replace the missing parts.

Repair.

Rub down and treat damaged edges.

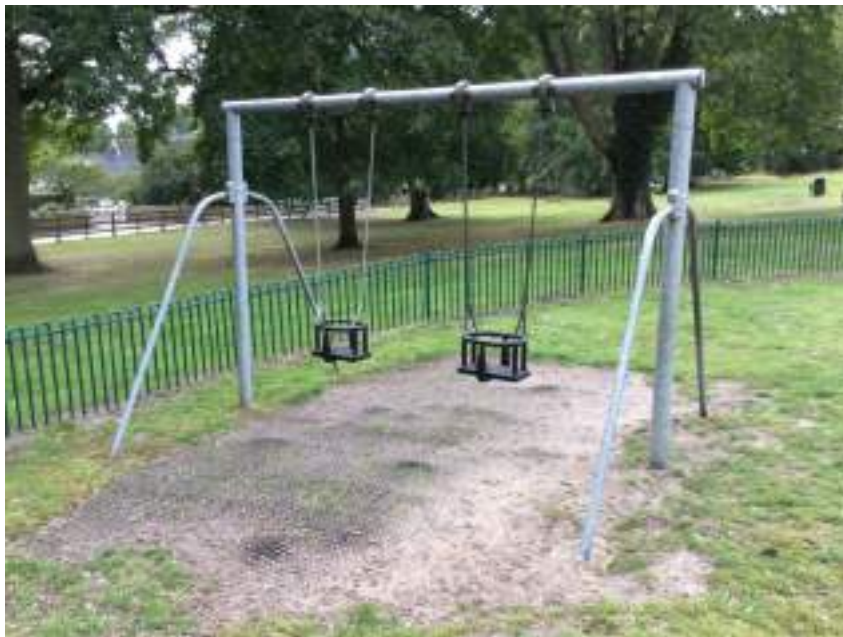
Swing - Toddler - 1 Bay 2 Seat

The covers should be removed from the fitting at the top of the chain annually and the shackle bolt should be checked for wear.

Replace at 70% of original diameter (30% wear).

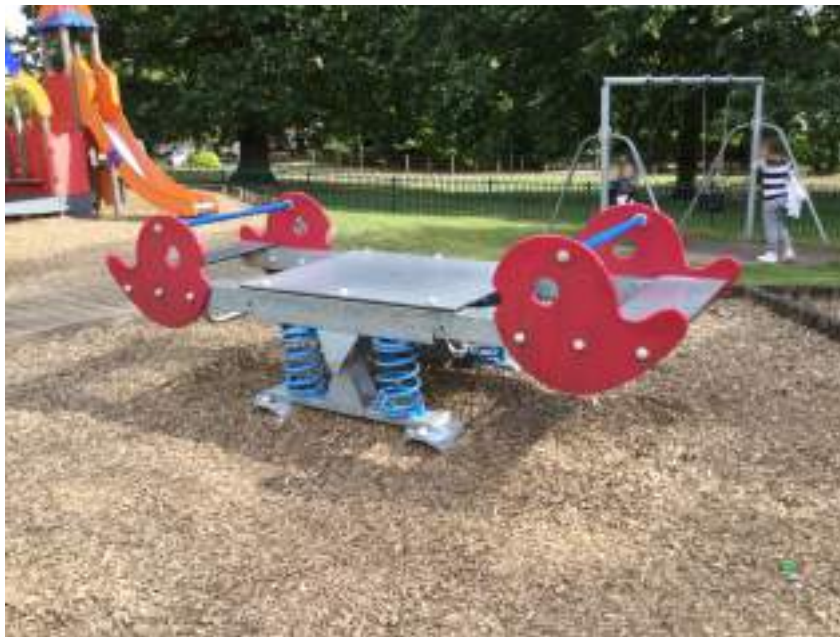
Rocker - Seesaw - Multi-Seat

Rivets are missing.

Item has some parts missing.

Top of unit is missing a part. Potential finger entrapment present.

Replace.

Replace the missing parts.

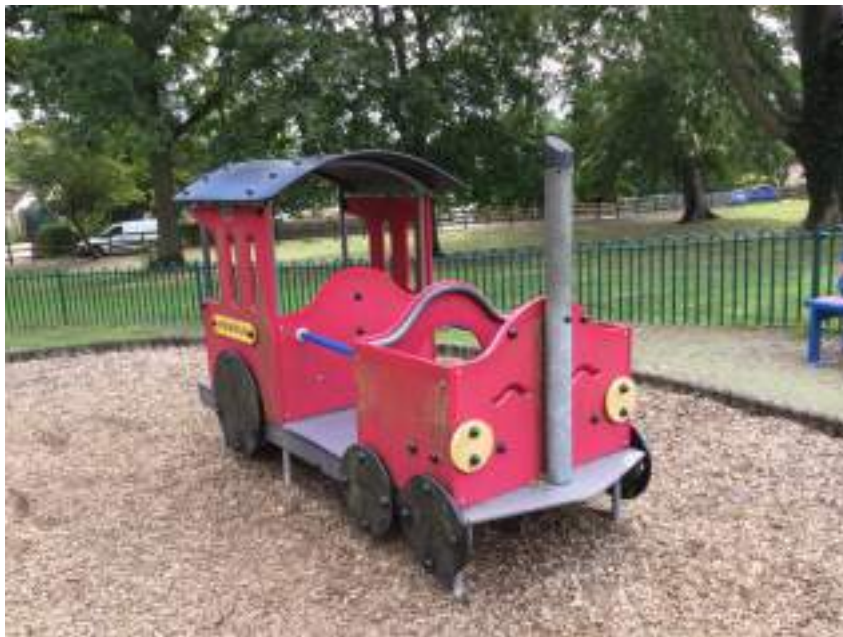
Play Train

Bolt is missing.

Bolt missing on chimney, leaving a potential finger trap.

Replace.

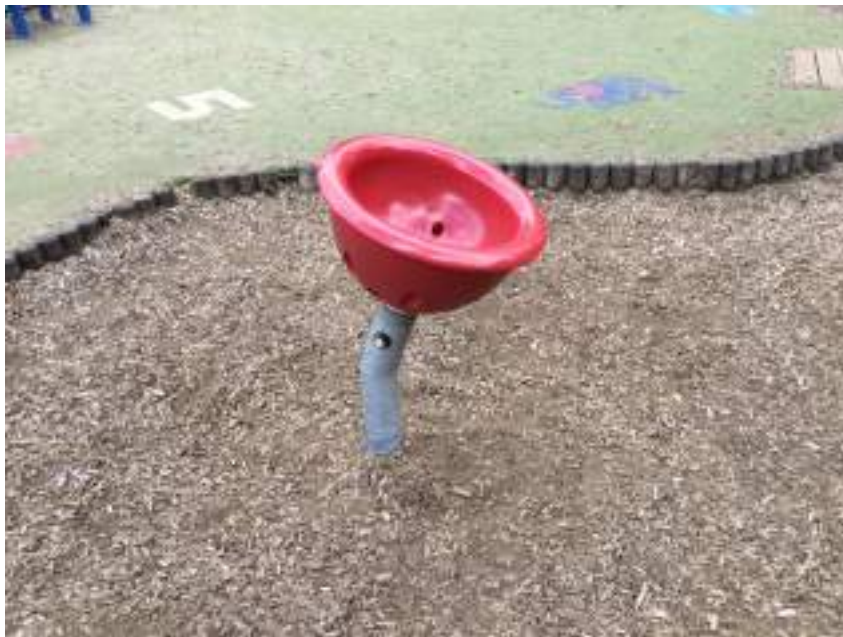
Carousel - Bowl

Loose fill levels are too low to provide adequate protection.

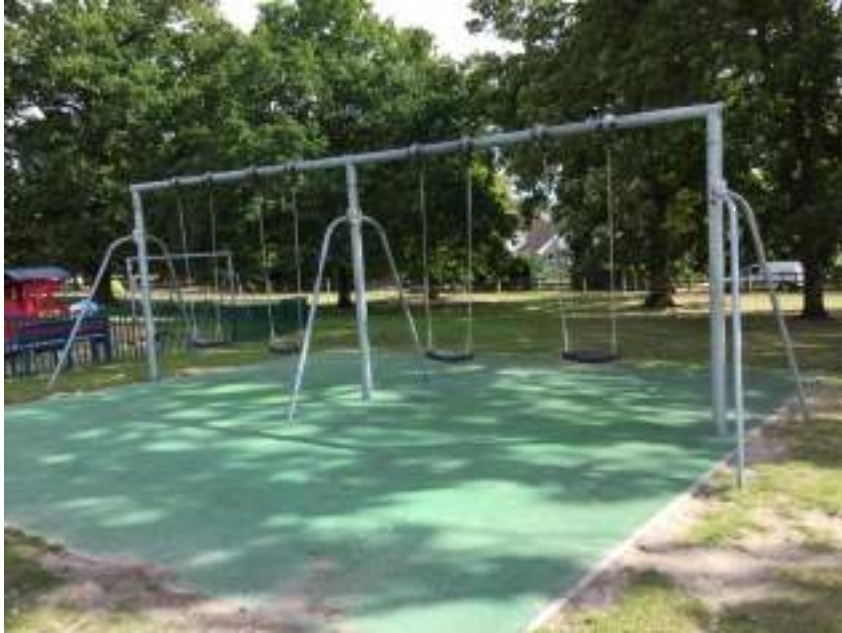
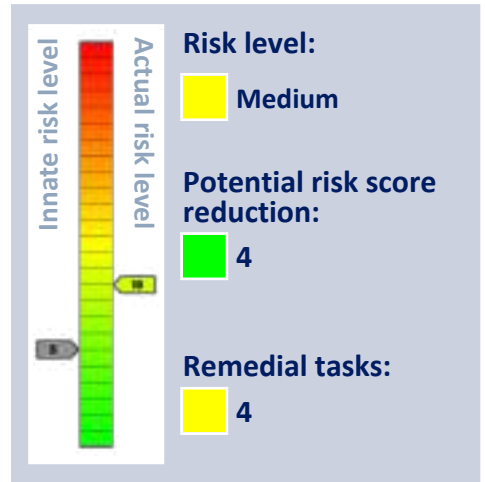
Swing - Junior - 2 Bay 4 Seat (2300 mm) (External)

Bolt(s) missing.

The covers should be removed from the fitting at the top of the chain annually and the shackle bolt should be checked for wear.

Tighten/replace.

Replace at 70% of original diameter (30% wear).

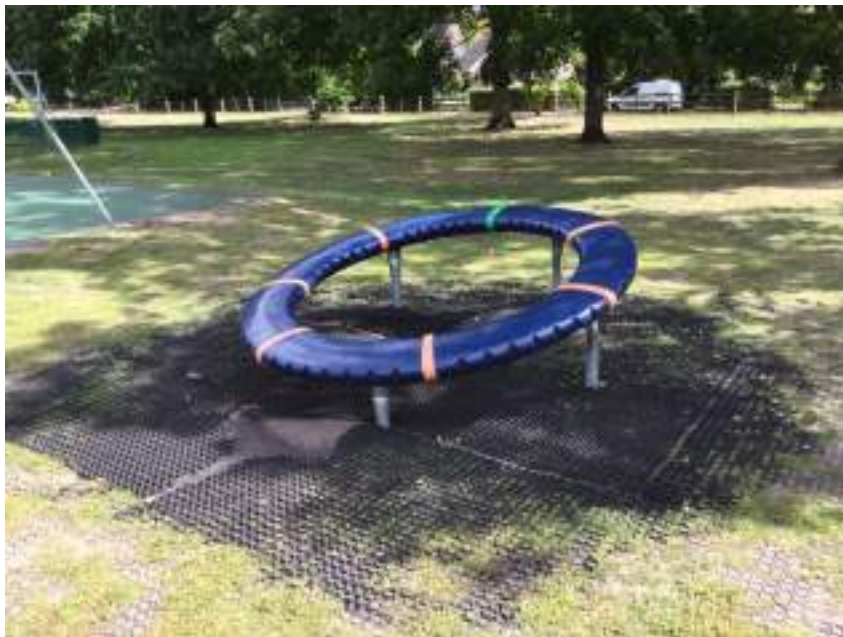
Carousel - Supernova (External)

Surface needs repair.

Mats damaged and missing - repair / replace.

Repair., Replace.

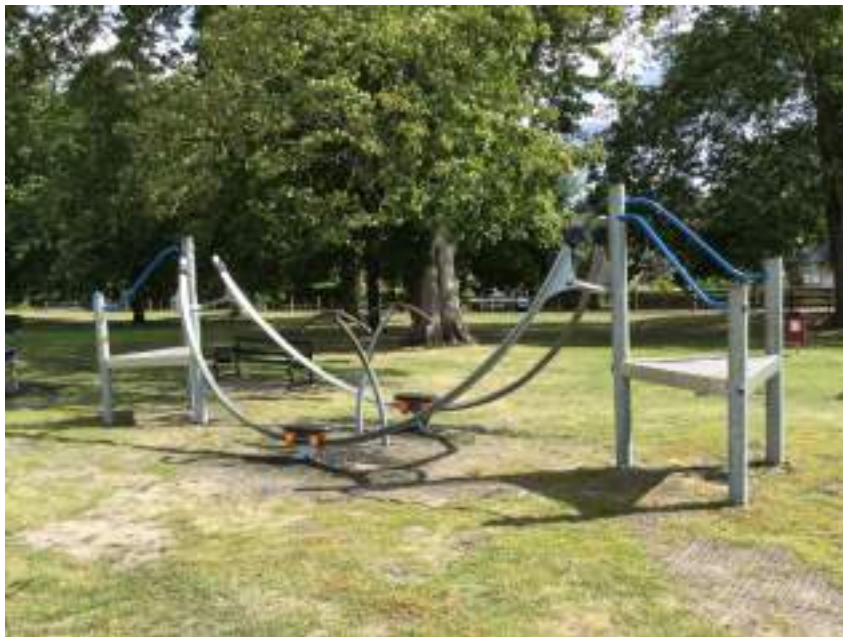
Runway - Rigid - Skate (External)

Bolt(s) missing.

Cap missing.

Item is damaged.

Rubber traveller damaged - monitor.

Surface needs repair.

Replace missing bolt(s).

Replace.

Repair.

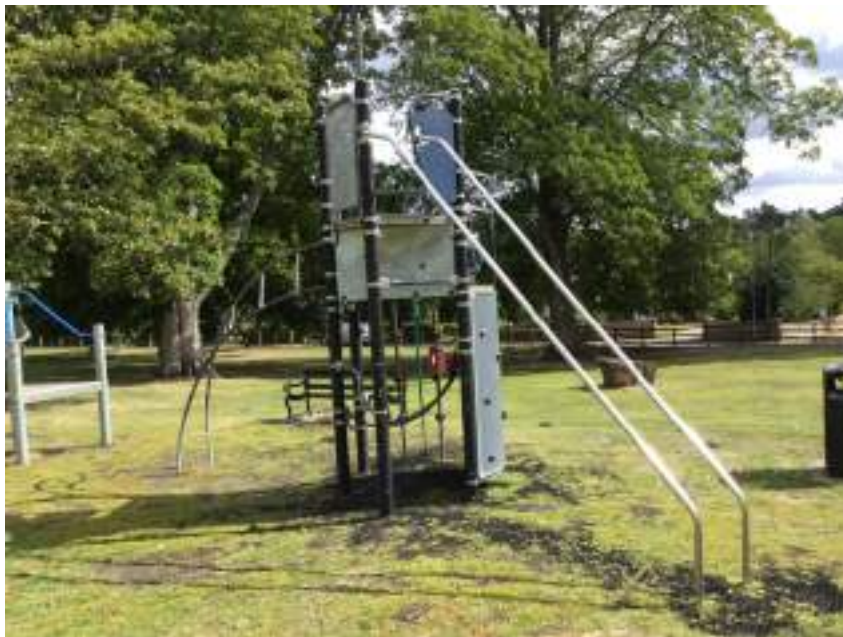
Multiplay - Senior (External)

Surface needs repair.

Repair.
