Safety Inspection Report

Annual Inspection

Pine Close, IP24 3LA

Thetford Town Council

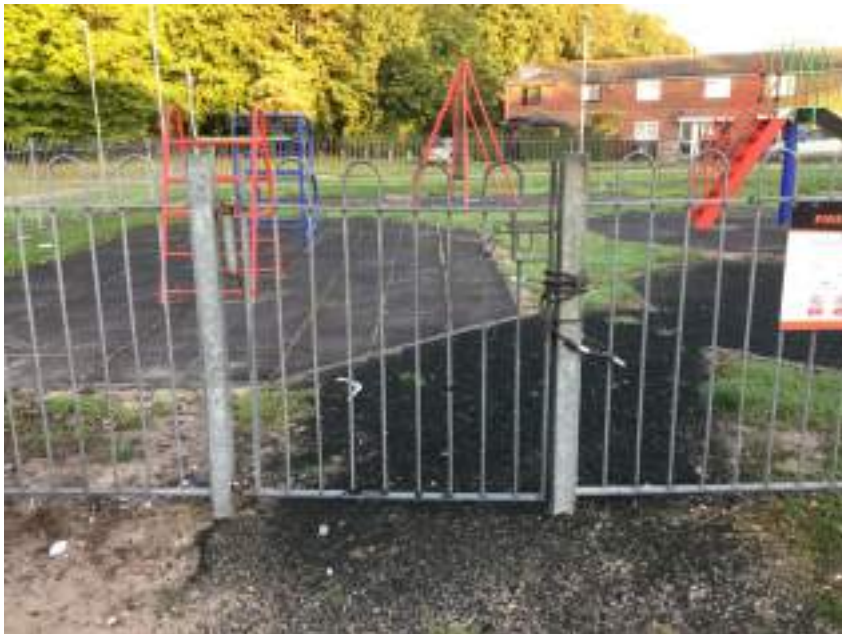
Gates

Gate buffer(s) required.

Item has some parts missing.

Bar on gate missing, allowing animals to enter.
Bolt is also missing.

Fit a buffer.

Replace the missing parts.

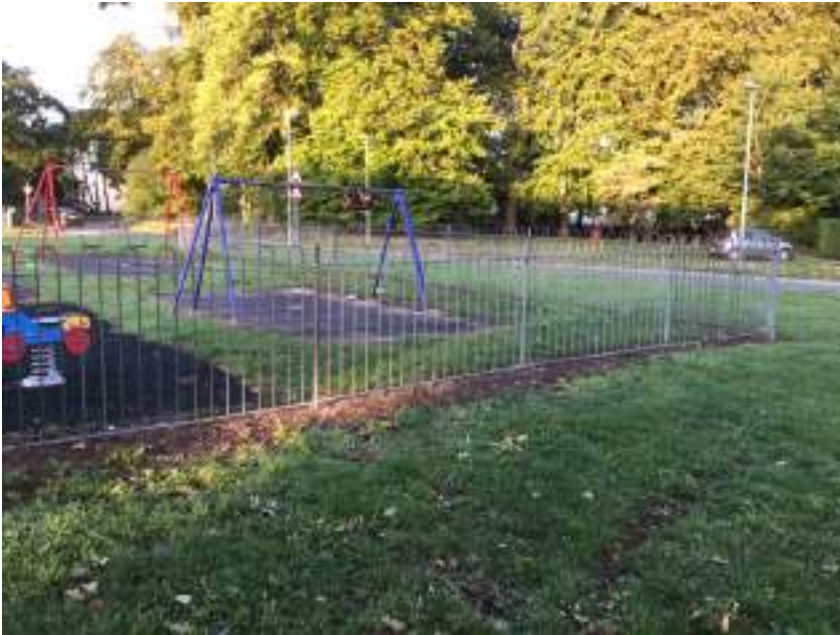
Fencing

Item is damaged.

Repair.

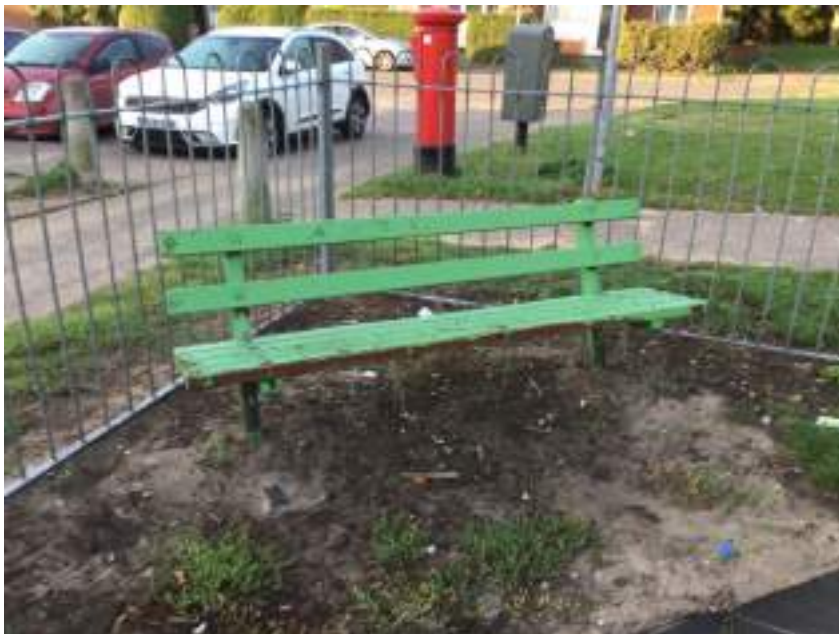
Seating

Cap missing.

RoSPA recommend a minimum distance of 1 m between seat and fence. This is to reduce the likelihood of children vaulting the fence via the seat.

Replace.

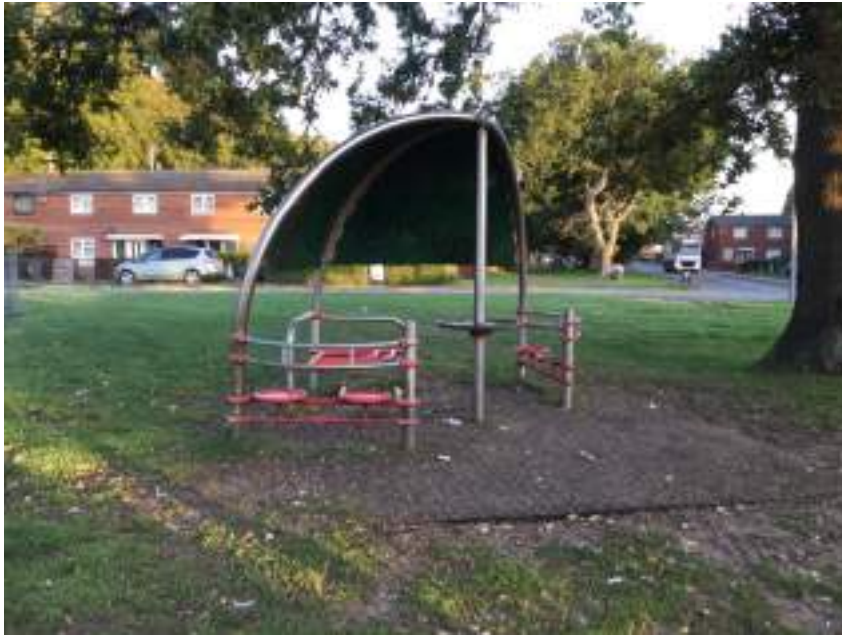
Youth Shelter

Cap missing.

Item is damaged.

Item has some parts missing.

Metal coping for roof panel missing, leaving sharp areas exposed.

Replace.

Repair.

Replace the missing parts.

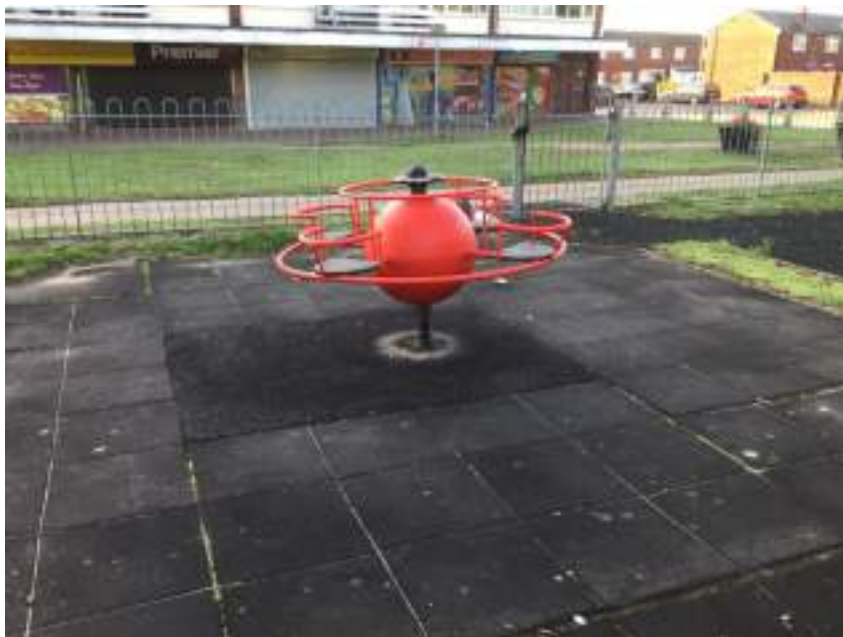
Carousel - Sputnik

Gaps have opened up between tiles causing trip hazard.

Minor repairs are needed.

Edges of tiles and tiles themselves are lifting - Repair.

Repair.

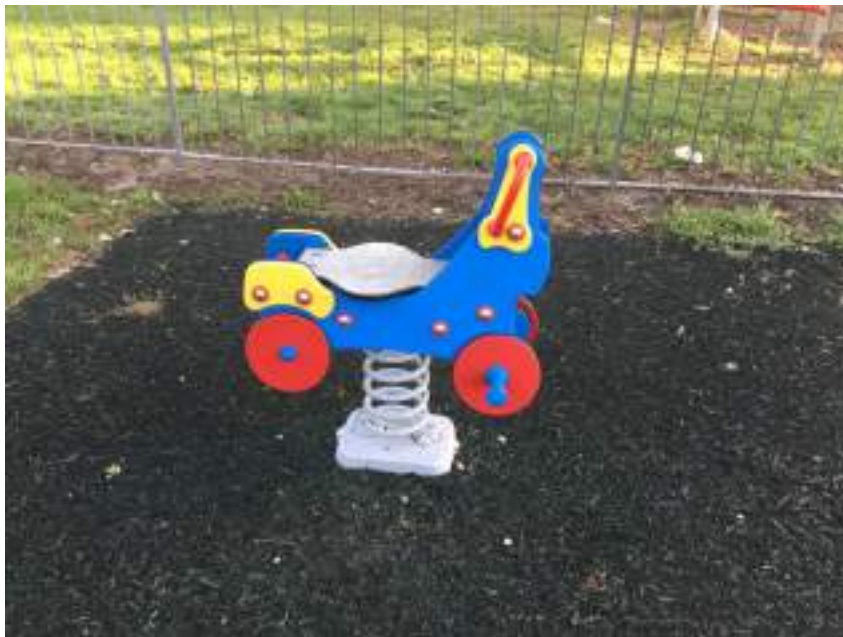
Rocker - Bike

Fixtures loose or missing.

Tighten/replace.

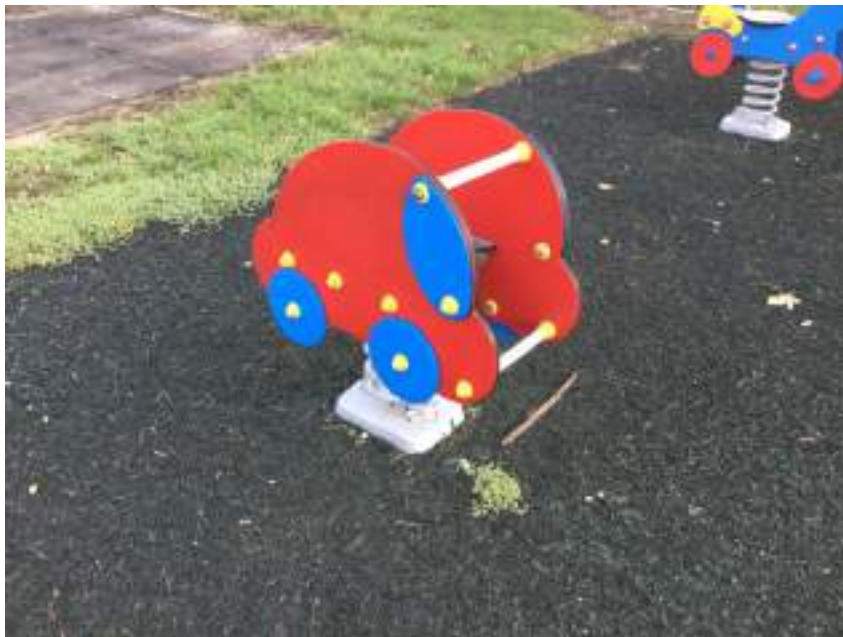
Rocker - Car

Cap missing.

Bolt(s) loose.

Frame bolts loose to spring. Tighten.

Item is cracked.

Replace.

Repair.

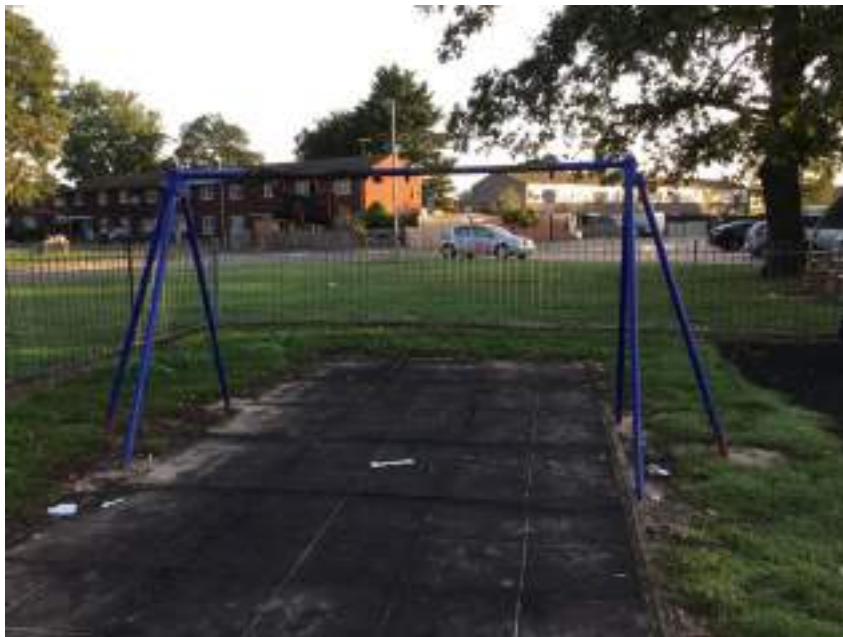
Swing - Toddler - 1 Bay 1 Seat

Gaps have opened up between tiles causing trip hazard.

Swing seat(s) missing.

Replace.

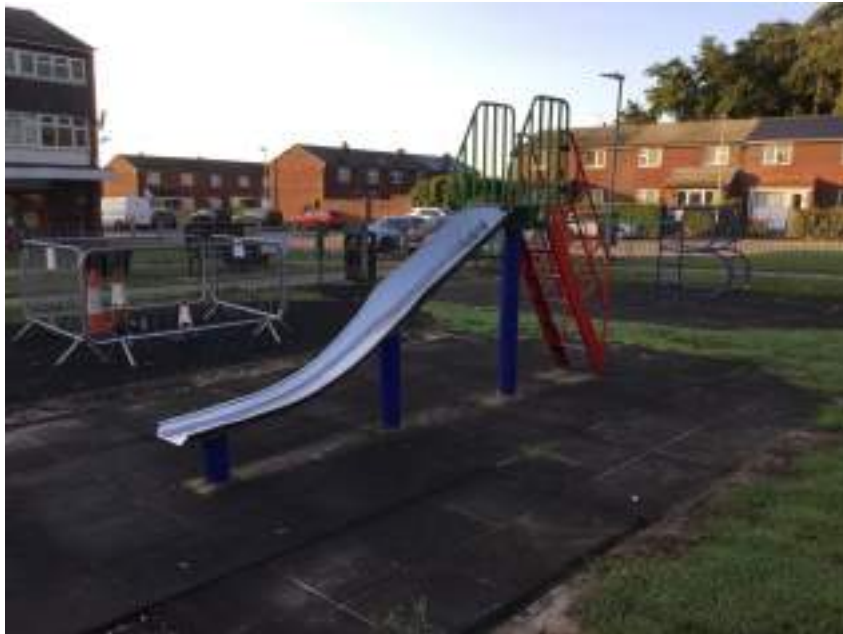
Slide

Gaps have opened up between tiles causing trip hazard.

Along the wooden edges and connection joint to rubber mulch. some matts and edging are missing - Replace.

Access fails the entrapment requirements.

Make level., Repair.

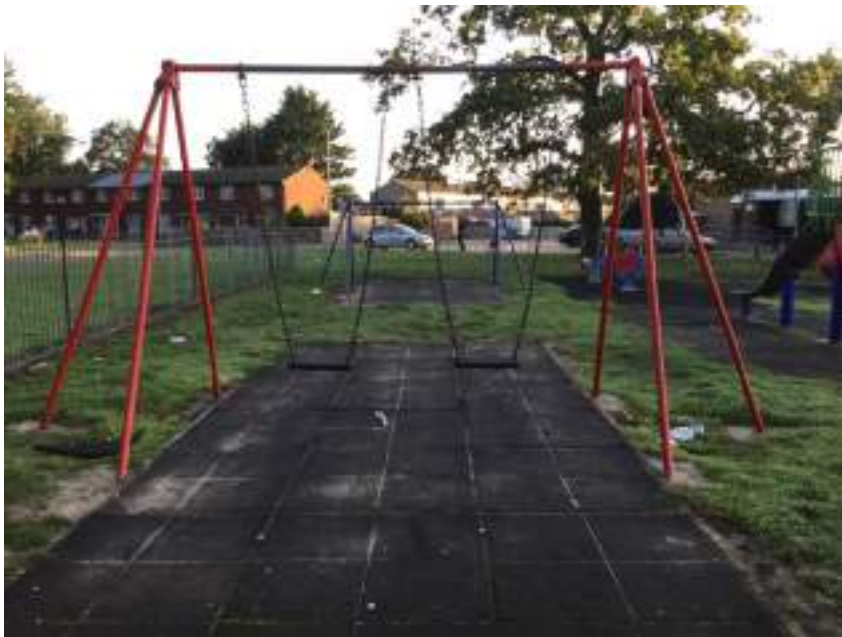
Swing - Toddler - 1 Bay 2 Seat

There is wear in the bushes.

Gaps have opened up between tiles causing trip hazard.

Bolt(s) loose.

Cross bar is loosening in support housing. Tighten.

Remove shackle bolt and check bush and shackle pin wear, replacing as necessary.

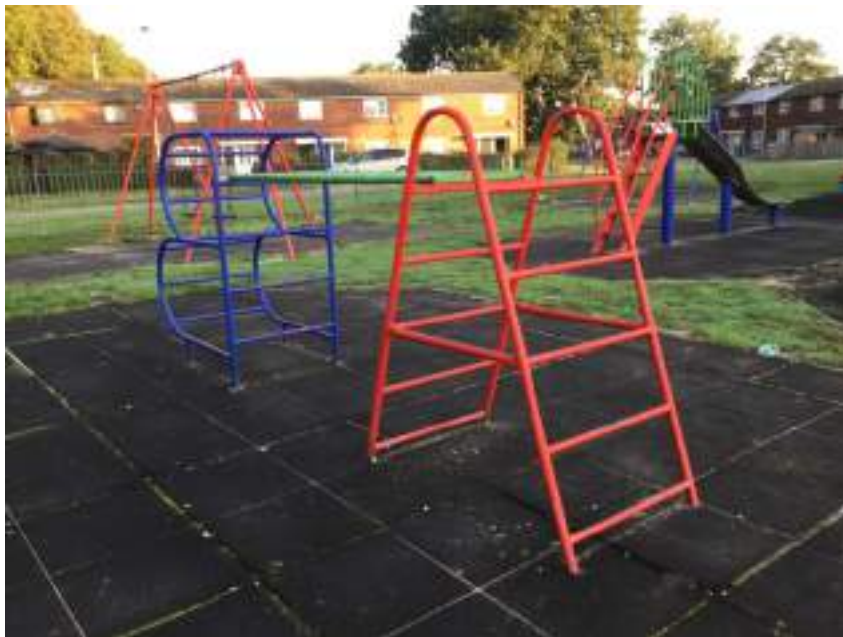
Climber - A & B Frame

Fixtures loose or missing.

Gaps have opened up between tiles causing trip hazard.

The protective surface under all bars and rings must be kept in good condition.

Minor repairs are needed.

Tiles lifting and wooden edging is missing / decayed.

Tighten/replace.

Repair., Replace.
